# Flood-Damaged Channels and Farmland Restored

Report on  
Flood Rehabilitation Work  
by the Soil Conservation Service  
in the Great Plains

U.S. Soil Conservation Service

Region 5, Northern Great Plains

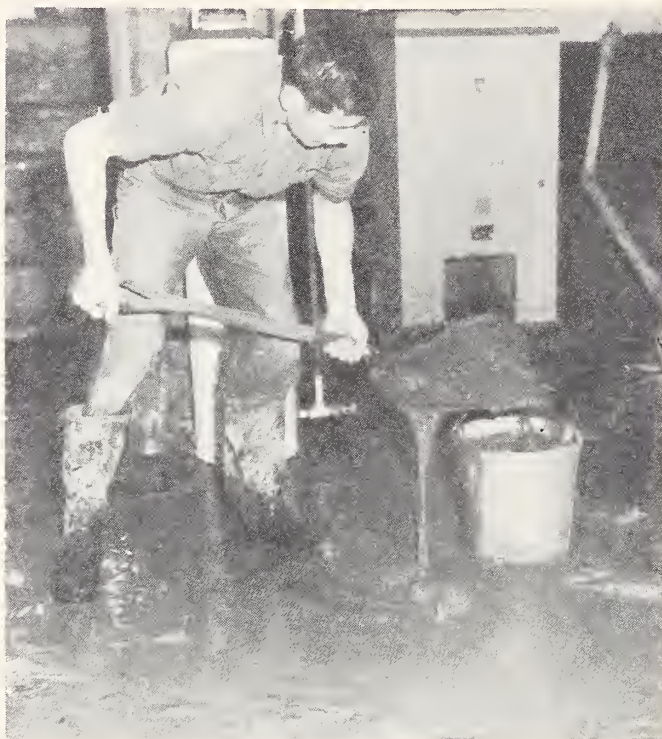
Damage done to farms by the flood-producing rains and flooding streams reached record proportions in Kansas, Missouri, Nebraska and Oklahoma. Nearly two-thirds of the damage resulted from sheet erosion on the watersheds. Nearly 10 percent of the damage was to bottomland. Crop losses, loss of livestock, and damage to pastures, build-

ings, fences and other agricultural property on bottomland farms accounted for the rest, or about 25 percent, of the total damage.

In the Kansas River valley alone, about 100,000 acres of bottomland was covered with heavy deposits of sand or silt, or deeply scoured. Most tributary channels were choked with debris, or otherwise damaged.

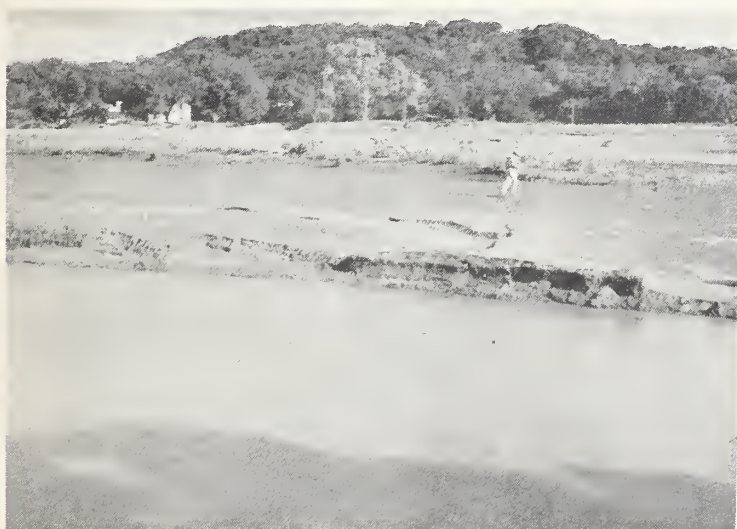
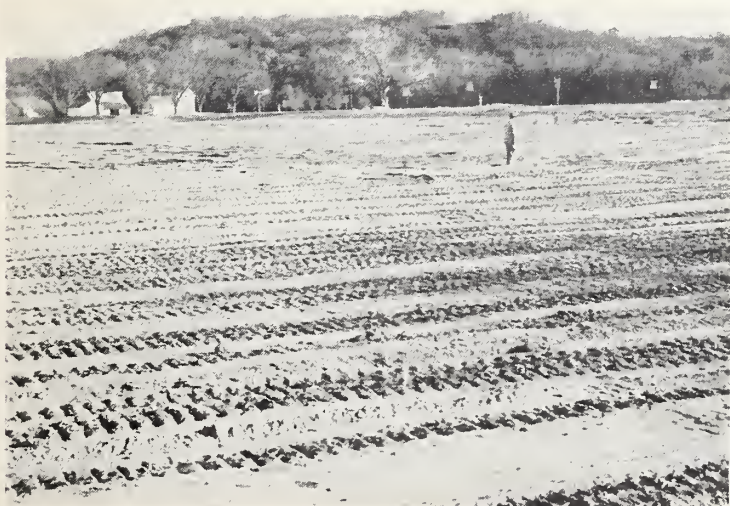
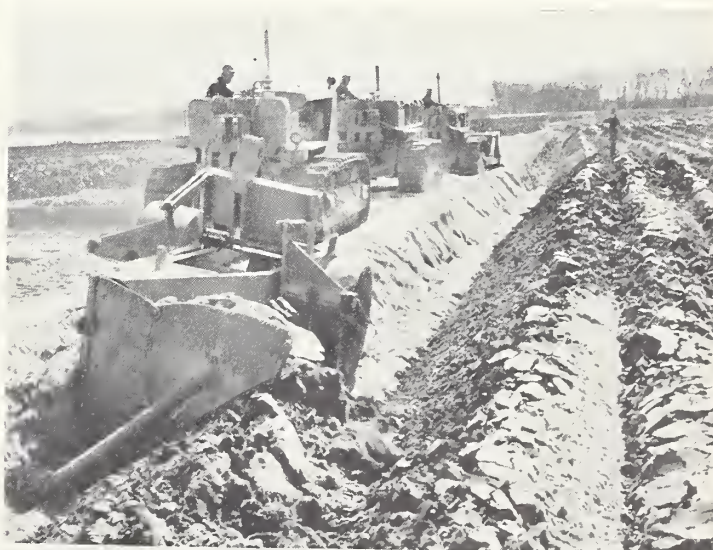
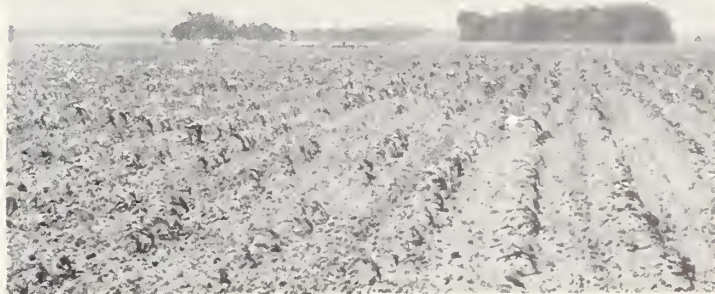
## Fertile Bottomland Returned to Production

Below are two examples of farmland rehabilitation and on the next 10 pages are pictures depicting five representative channel restoration jobs.

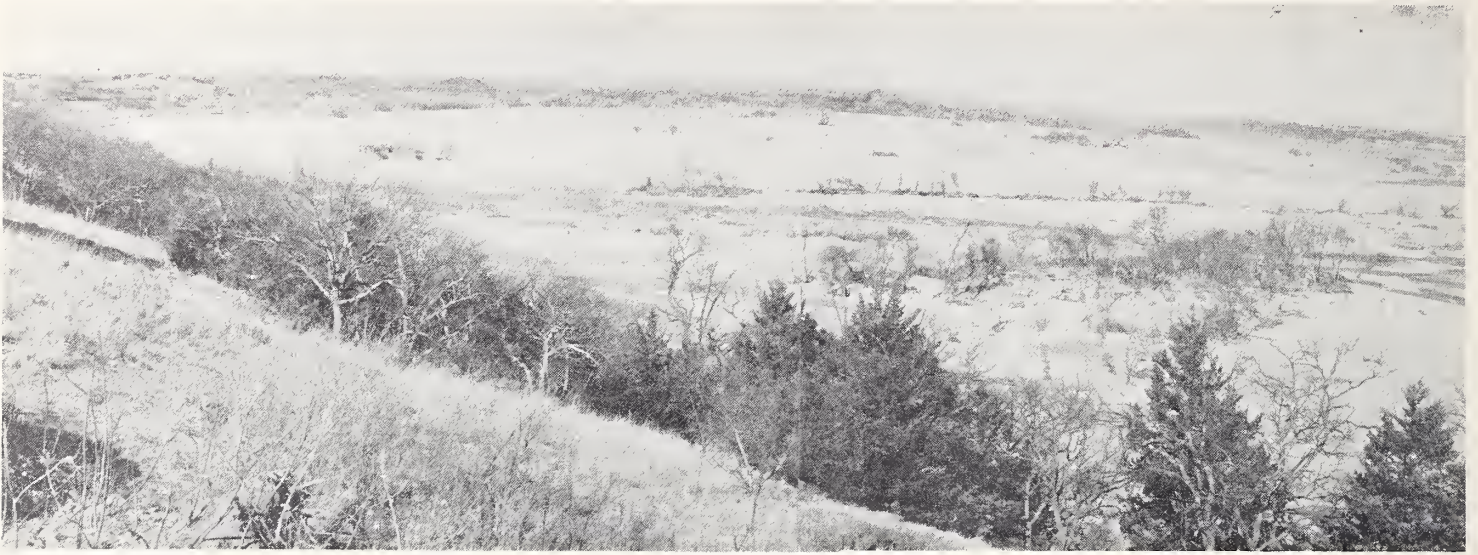
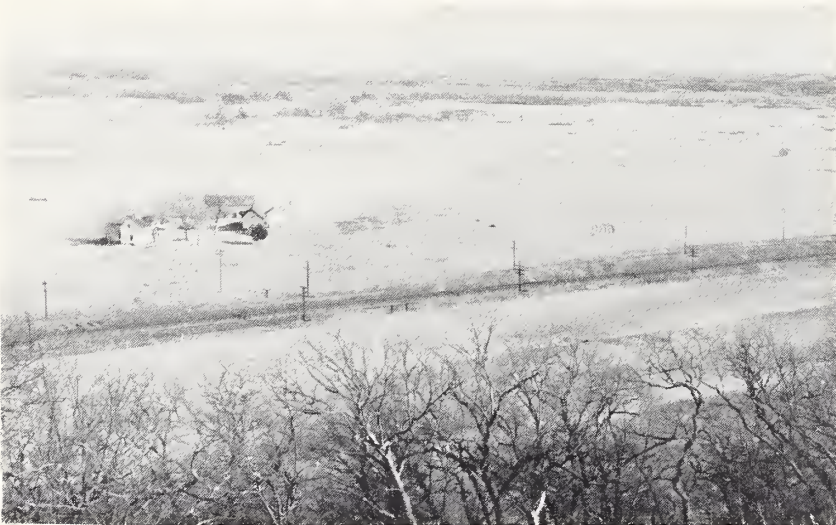
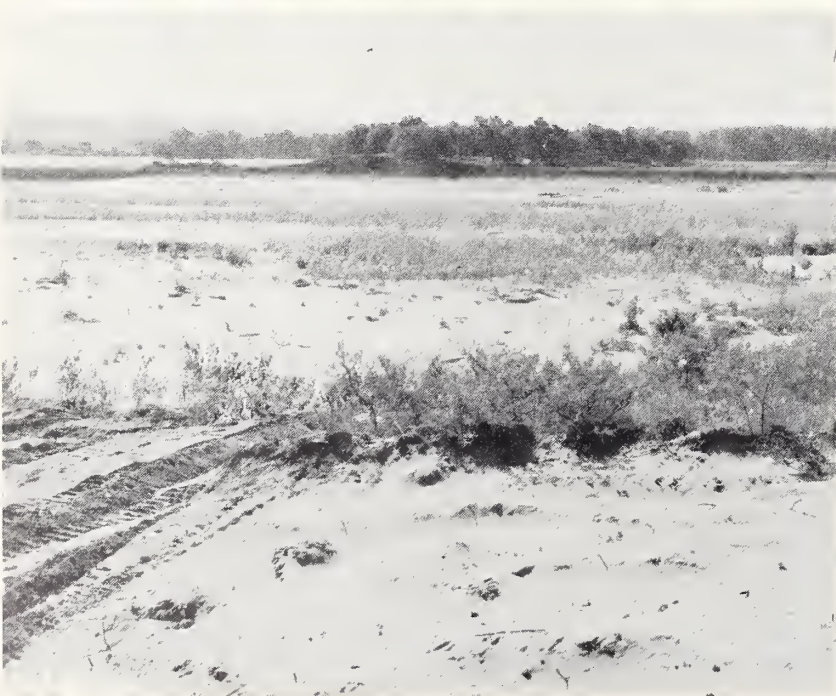
For ages before the 1951 flood of the Kansas River, a natural barrier had kept the river away from the land seen in the upper picture. That picture shows part of the 2,500 acres of the Hunter's Island and Moehlman communities that were flooded when the river destroyed nearly all of the barrier. Destruction of the barrier also opened the way for flooding of part or all of this land in the future every time the river rose more than four feet.

The center picture is an overall view of where the natural barrier was. It extended from the small building at the right to a remnant of the natural barrier in the center of the picture, and from there to the trees in the background. A close-up of the area in the background, taken before rehabilitation work, is seen in the lower picture.

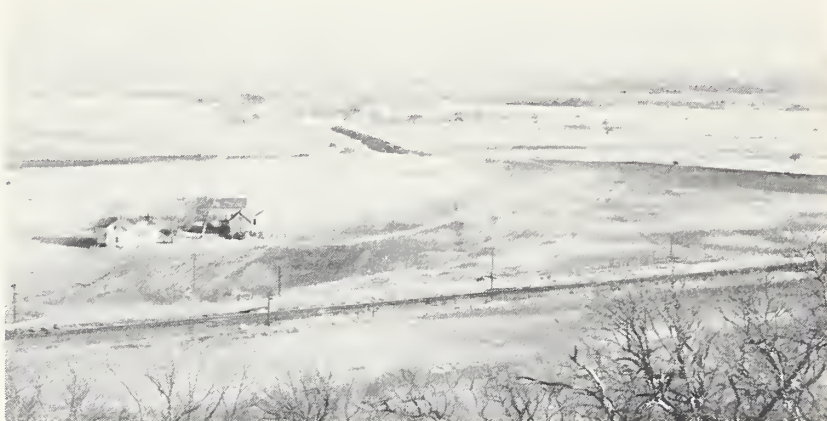
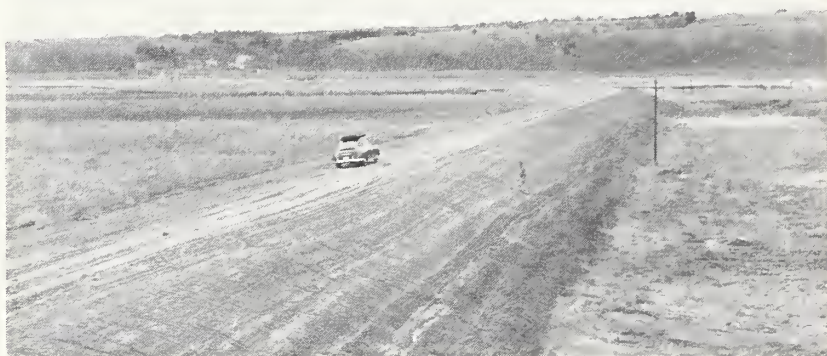
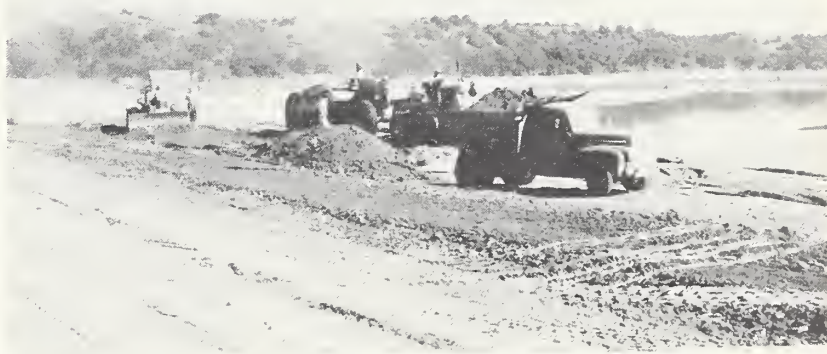
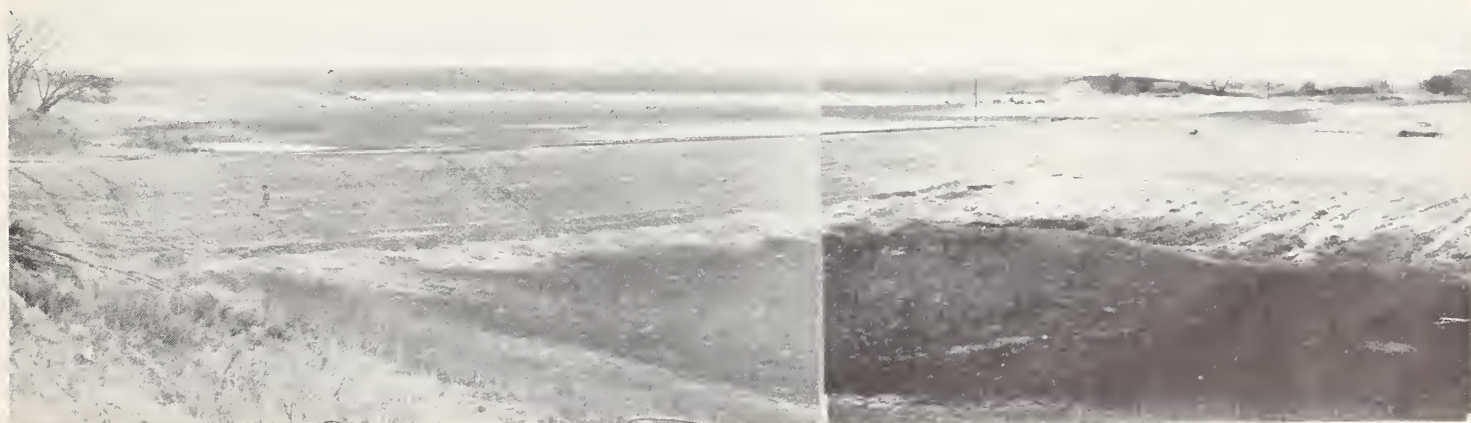
A new barrier now stands guard over the Hunter's Island and Moehlman communities' lands. The upper picture, a repeat of the center picture on page 6, shows part of it. Trees in the center of the picture obscure the other part.

The second picture from the top is a close-up of the part of the barrier shown in the upper view, but looking in the opposite direction.

Equipment used on construction is seen in the third picture. Clay was hauled from a mile away, since soil in the area where the barrier was built is sandy. Water to the right is not part of the river. It is standing water in an area gouged out by the flood. The barn in the background is the same barn that is seen in the top picture.

The bottom picture shows the part of the barrier built at the place shown at the bottom of page 6. The river is in the background.

Residents of the area secured the right-of-way for realignment of the barrier. Some of the right-of-way was costly. The Union Pacific Railroad gave a substantial sum to pay for supplies and to pay fees for state review of plans and approval of design. The Bayer Construction Co. of Manhattan, Kansas, got the construction contract. A total of 82,761 yards of earth was moved. The Riley County Soil Conservation District undertook the job of seeding the barrier to grass and establishing trees on the river side.

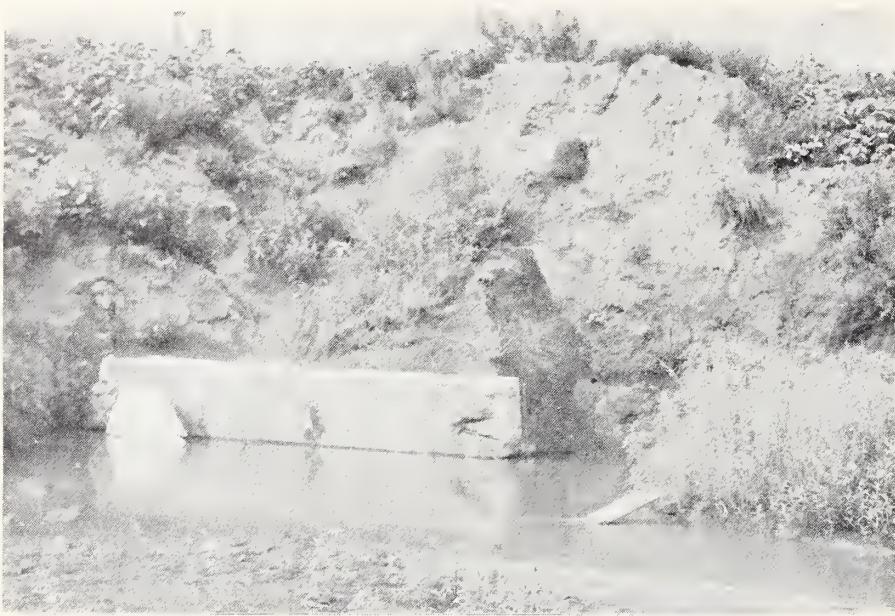
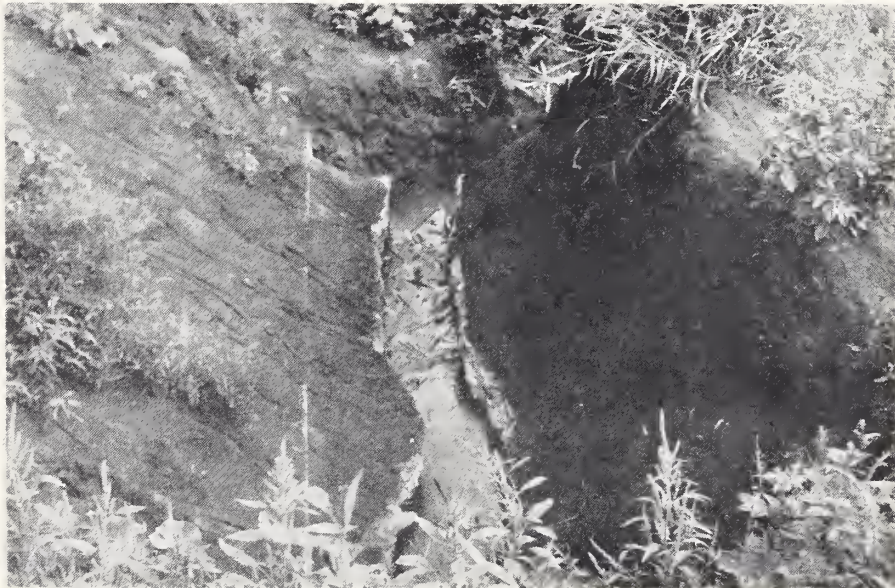
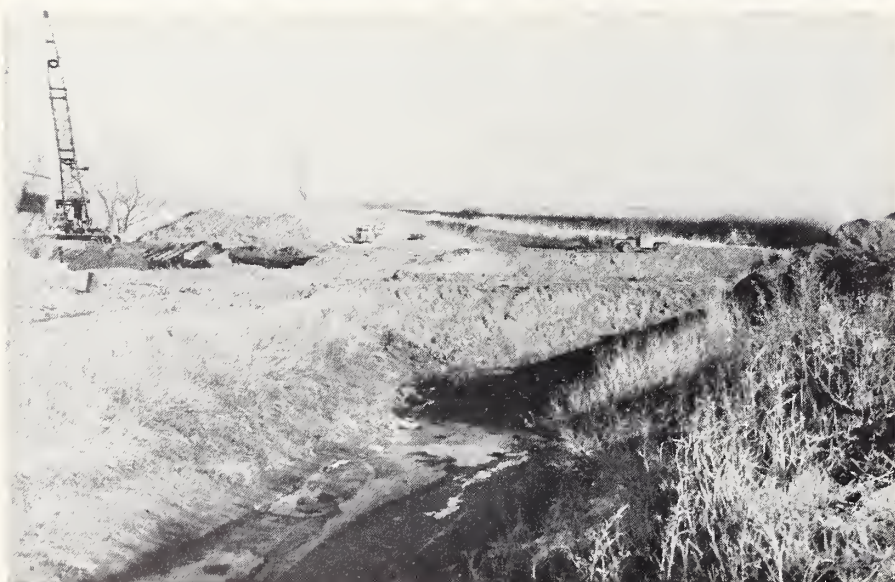
This structure, a flume beneath the Tekamah-Silver Creeks floodway aqueduct, was destroyed by the Missouri River flood. Its location was just below the junction of the Tekamah Creek and Silver Creek floodways, which had been built nearly 40 years previously to eliminate flooding by the creeks and the heavy damage to bottomland that resulted.

Stresses created by the Missouri River floodwaters broke the huge concrete structure at the outlet end. The broken part dropped, partially closing the triple 8x8-foot box-type culvert structure.

The upper picture, taken from the bottom of the drain, shows the concrete that had broken loose and settled. The middle picture, taken from above, shows the break.

The lower picture shows one of the draglines used to dredge the new stretches of drain above and below the new flume, and the trench into which the new flume would be put. This picture was taken looking east from just above the old flume. Part of the aqueduct channel can be seen in the foreground.

After examination, it was decided that the least expensive way to repair the drain would be to relocate the flume a short distance to the east. This also would eliminate two sharp curves in the channel.

Flood rehabilitation funds were used for materials and installation of the new flume, packing earth around the pipes, and construction of riprap to protect the outlet and inlet ends of the flume.

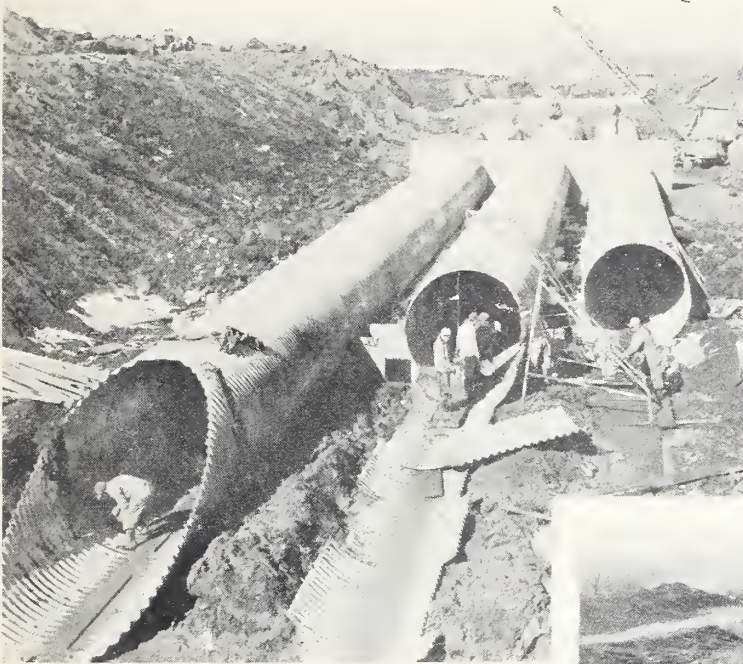
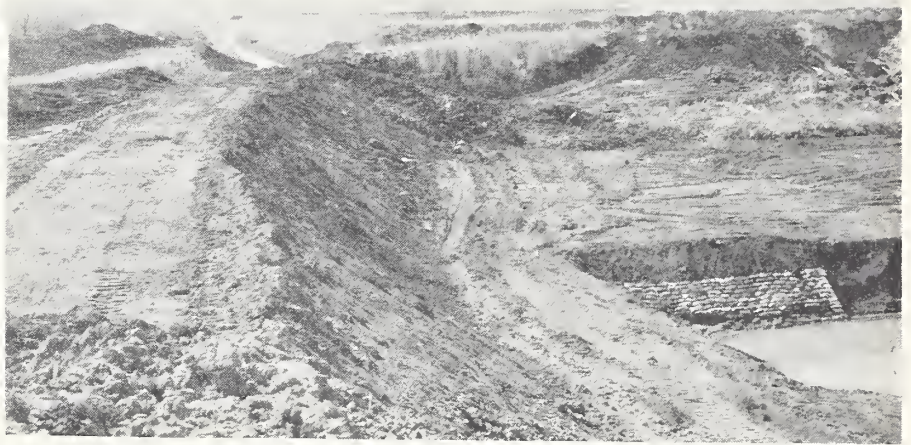
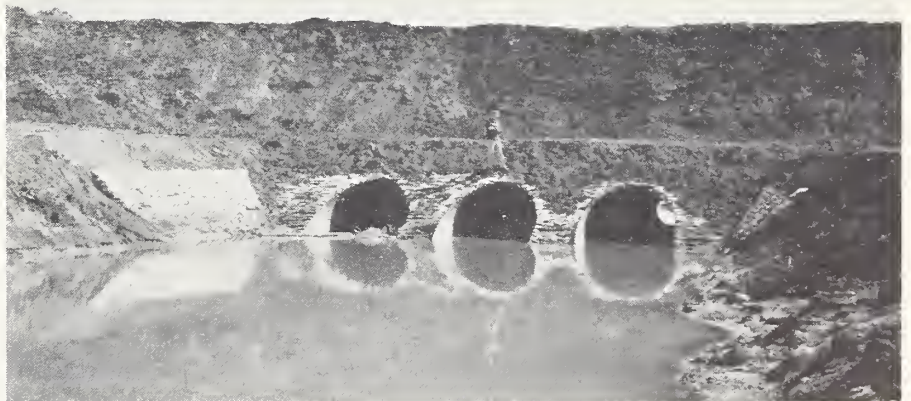
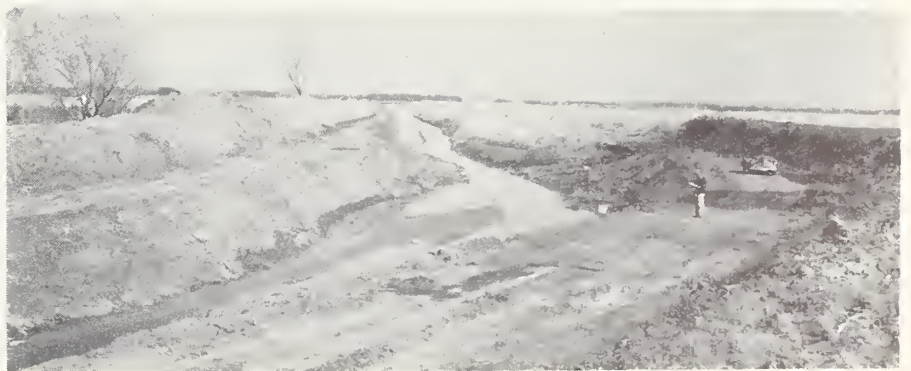
Rehabilitation of the Burt-Washington Drain necessitated the installation of three huge galvanized iron tubes.

Upper left is a picture of the tubes. Note their size, compared with the men working on them. Also, note how long they are. There is a large concrete collar at the midway point to provide added weight, and galvanized iron collars at each end to prevent seepage along the tubes. One of these is already in place in the background.

Upper right is a view of work on replacing the fill, after earth had been packed around the tubes.

The second picture from the top shows the fill completed. Part of the Tekamah Creek aqueduct can be seen in the background; the Silver Creek floodway is on the bank coming in from the right. This picture, looking west, was taken from the east end of the new fill. The old flume is under the embankment about in the center of the picture.

Second picture from the bottom is a view of one end of the new flume. Note the riprapping for protection.

The bottom view, looking east from the west end of the new fill, shows the aqueduct restored on the new fill.

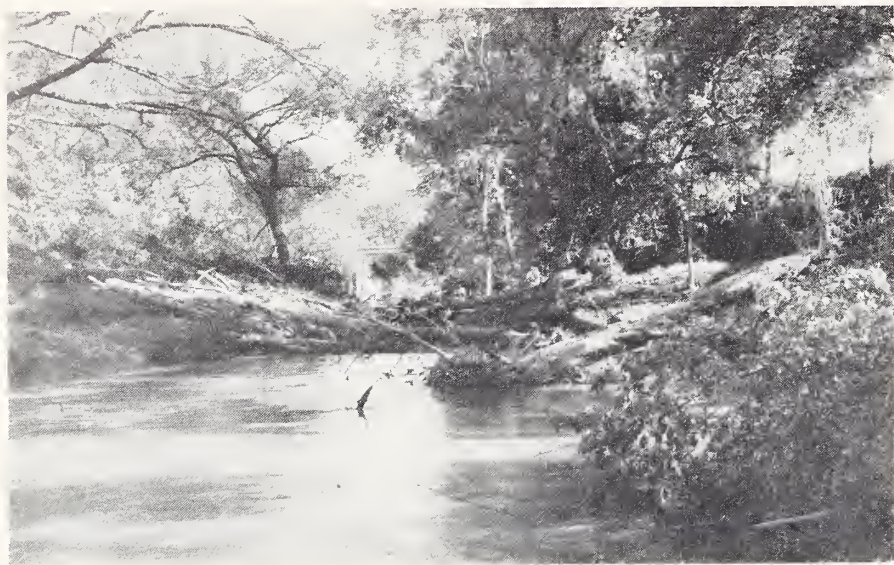
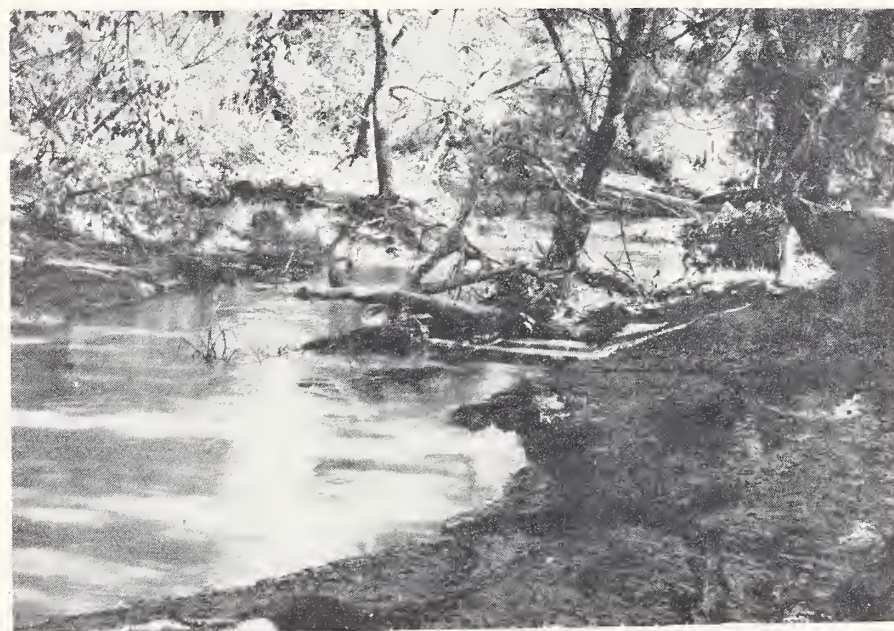
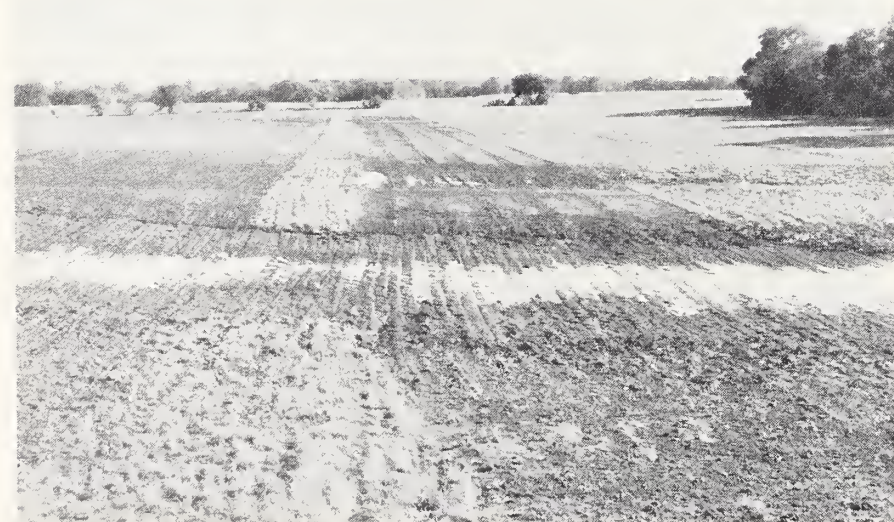
Channels tributary to the main streams were choked with sediment and debris, both in their upland reaches and where they cross the river bottomlands. Frequent flooding, in the future, of land adjacent to them was a certainty unless the channel blocks were removed.

The upper picture shows how the channel is blocked by dead trees and sediment that had been washed down by the floodwaters on their rush toward the Kansas River. Note how the channel block dams the water even at a time of low flow. The east-west state highway crosses the creek on the bridge seen in the background.

Even though the flow of the creek was low when it was taken, the center picture shows the stream to be out of its normal channel above the channel block.

Severe flooding of cropland occurred near the channel block shown in the top picture. This field is just east of the creek and south of the east-west road. Some scouring occurred at places where water is seen still standing on the surface. This is only part of the land that was flooded by water forced out of the creek because of damming of the channel.

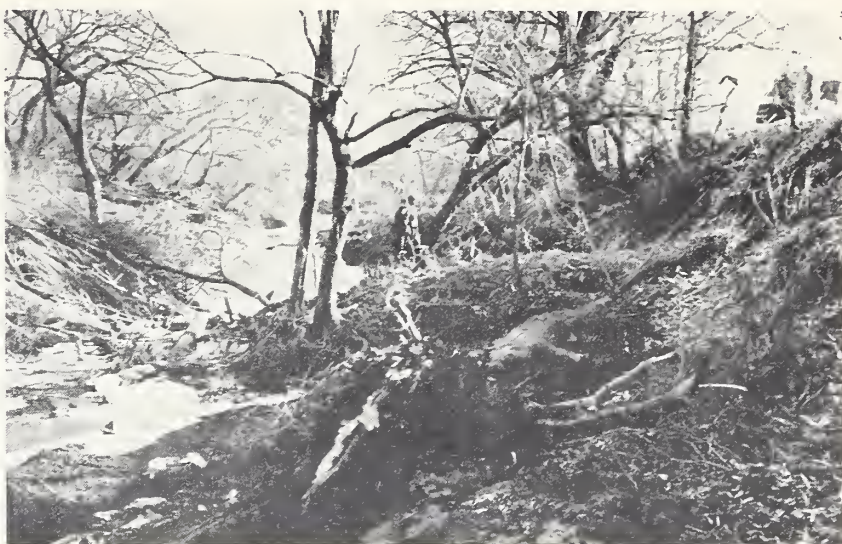
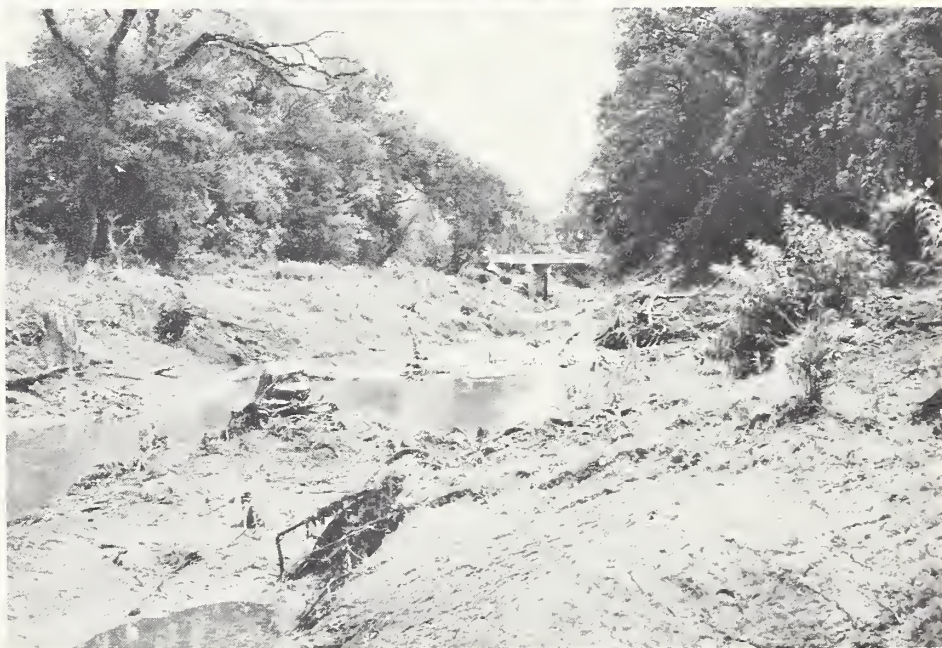
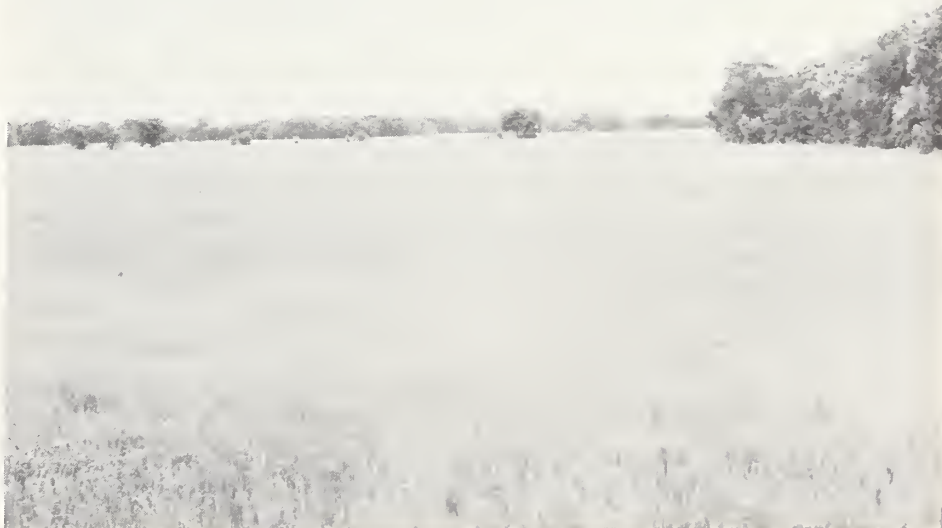
Men with power-driven chain saws, shown in the picture at the upper left, removed standing timber that obstructed the channel. Other men used a power-driven winch, seen on the top of the bank in the picture at upper right, to pull the timber from the channel block. The debris was piled on the bank for the farmers to dispose of it.

The picture at right center shows the channel of this section of Cross Creek as it appeared when the rehabilitation job was completed.

At the lower right is a view of the land that had been flooded, shown in the bottom picture on page 10.

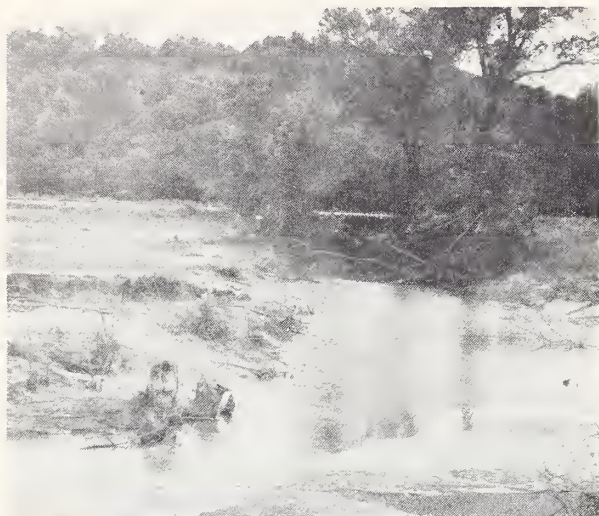
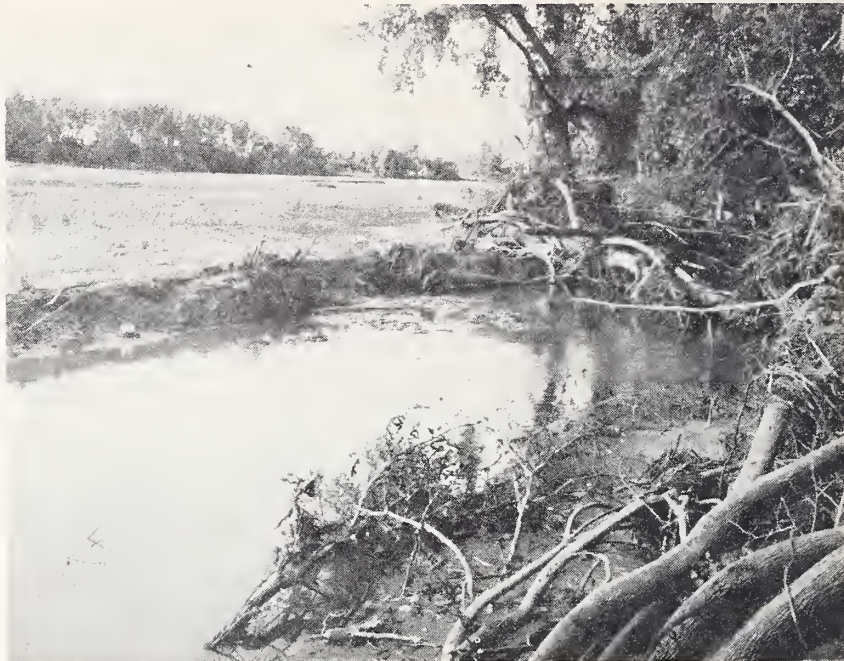
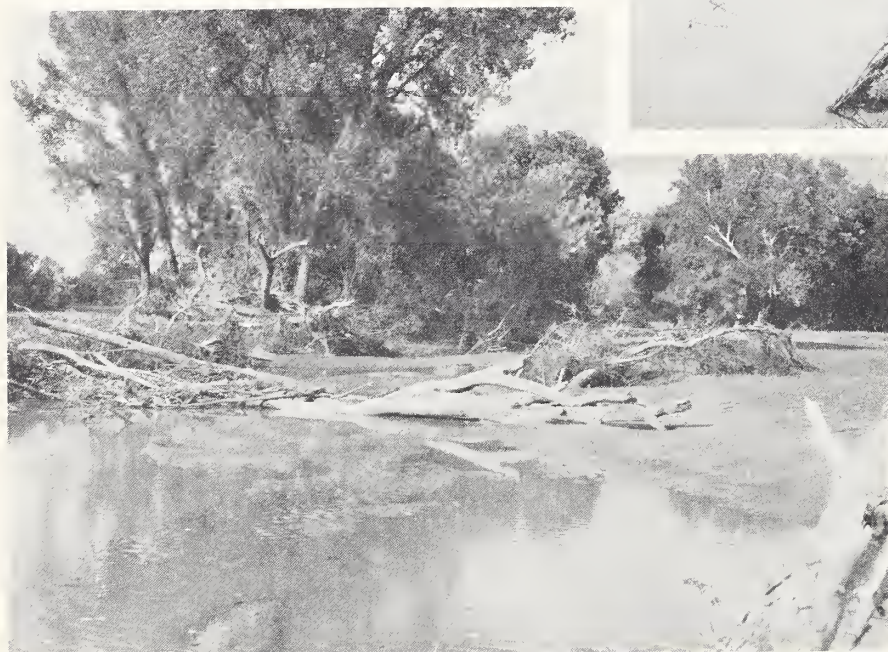
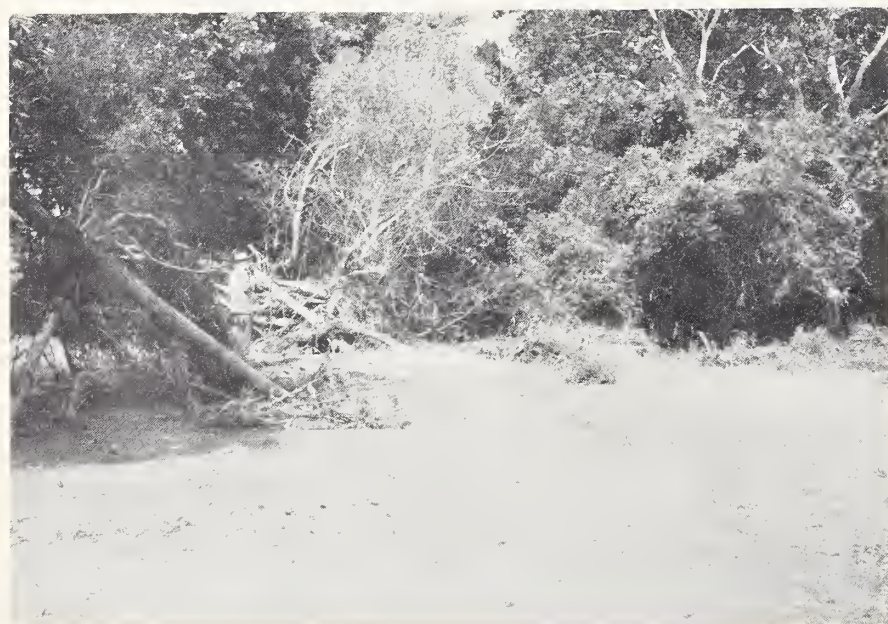
Kansas River floodwaters in 1952 filled Spring Creek, and others like it, with deposits of debris and silt that completely blocked the channel. As a result, fertile river bottomland faced flood threats that had not existed previously—new threats from the creeks, not the rivers.

The picture at upper left shows the channel blocked almost on its entry onto the bottomland. This block was just below the Santa Fe railroad tracks, which skirt the hills.

Another tangle of debris and silt is shown at upper right.

The middle picture is looking downstream at a block near the Kansas River. The channel had been obliterated. The bottom picture was taken about 50 feet farther downstream on the same channel block.

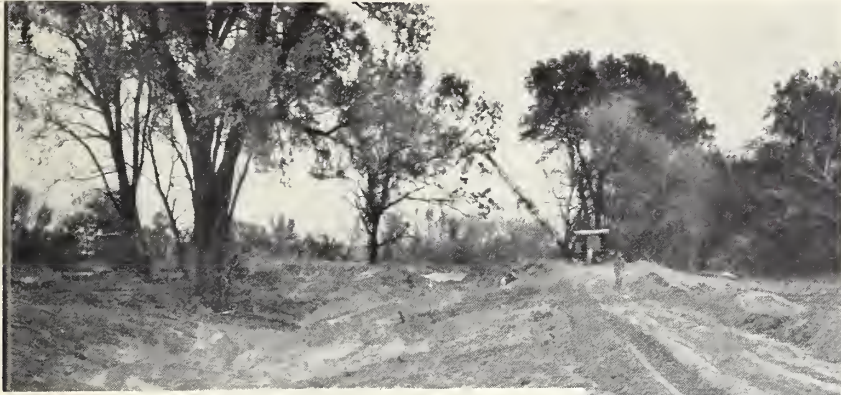
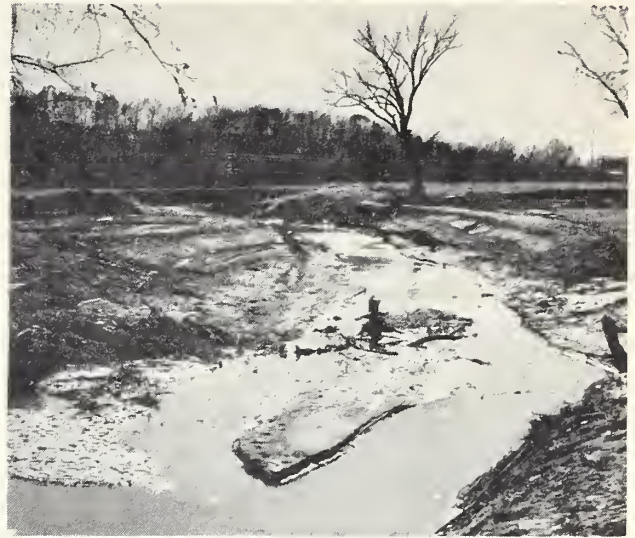
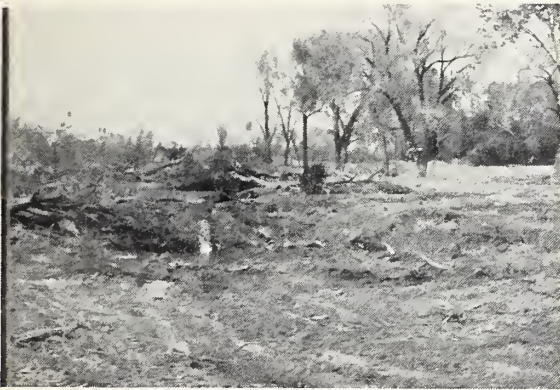
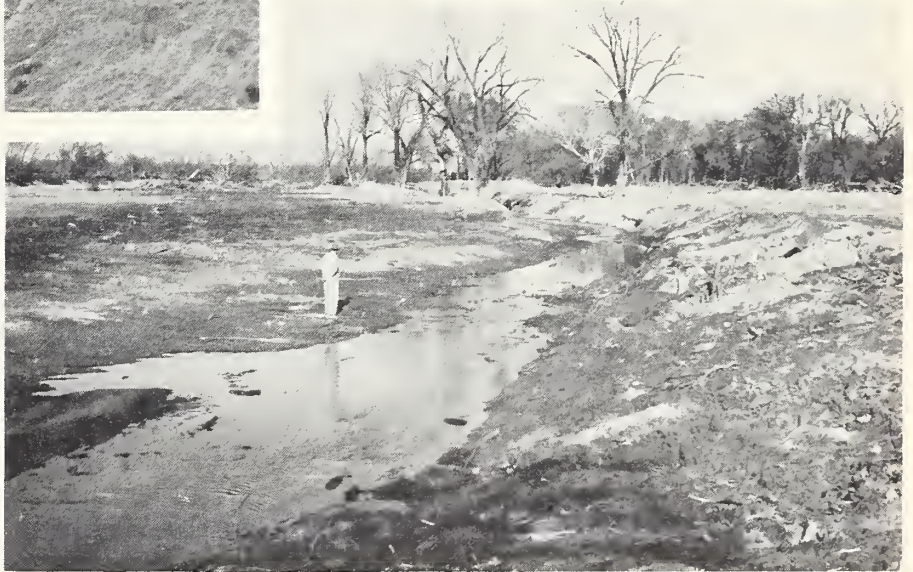
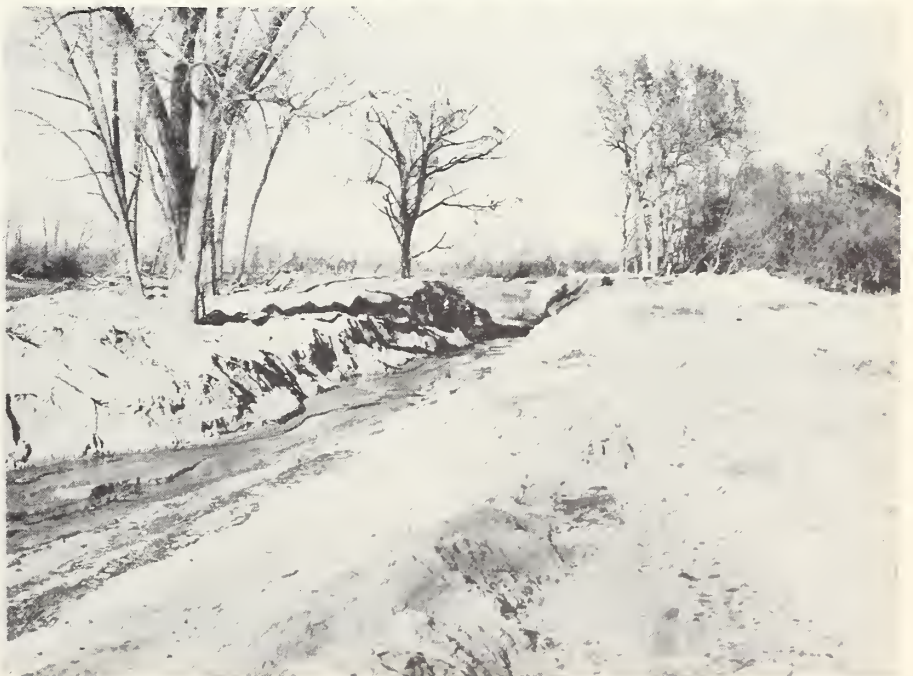
The picture, upper right, shows Spring Creek just below the Santa Fe tracks after rehabilitation.

At the upper left, a dragline is seen removing the silt that had been deposited in the channel. The tree in the left foreground is the one seen in the left foreground of the middle picture on page 12.

Before the channel cleaning could begin, the banks had to be cleared so that equipment could operate. The small picture, left, shows part of the creek after clearing.

The middle picture, right, is a repeat of all except the upper left on page 12. The man is standing at the place of the channel block shown at the upper right on page 12. The channel through the block shown in the lower pictures on page 12 is in the background.

Below is a close view of the channel near the Kansas River. Note the depth of the silt deposit there.

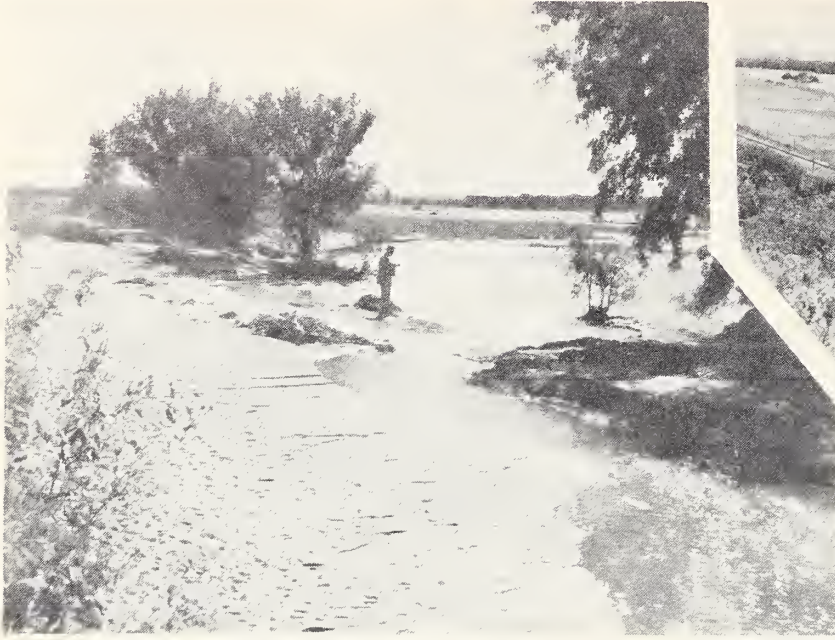
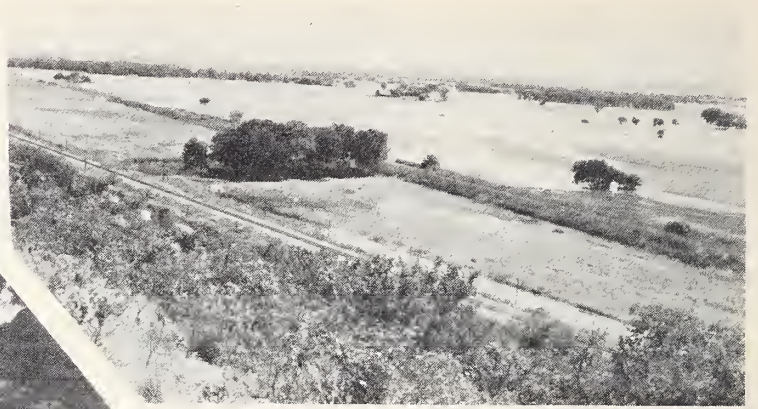
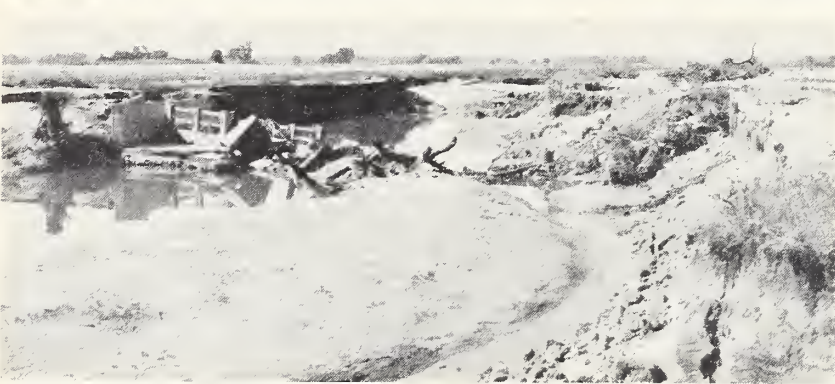
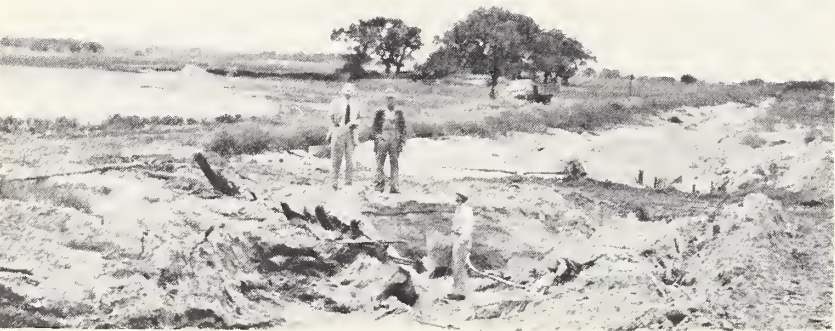
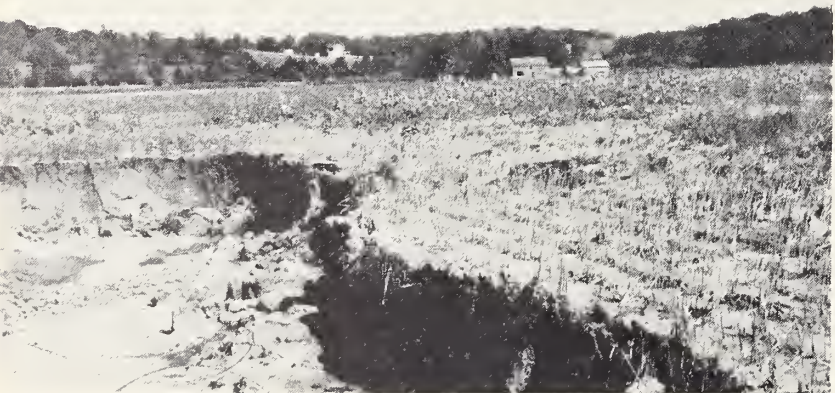
This drain is about 4 miles long. Floodwaters from the Kansas River went over the drain's banks, deposited much sand in the channel, broke the banks at places, and at other places, wrecked the drain. Lee Creek was flowing. The water went through one of the breaks near the upper end when it encountered the blocked channel.

The picture on the upper left shows where Lee Creek went through the break. You can see that the silt deposit to the left is deep. To the right of this picture is a view of part of the land protected by the drain.

Second from the top is a view near the lower end of the drain. Here the floodwaters destroyed a concrete bridge and made a general mess of the channel.

Below that picture is a scene midway along the drain. A wall of a building had become lodged in the channel, trapped silt, and made a real channel block.

The bottom picture shows a side of flood damage not usually thought of. It is the side-cutting that results when floodwaters run uncontrolled to a drainage. Gouging on this fertile bottomland field was done by the Kansas River floodwaters in 1951.

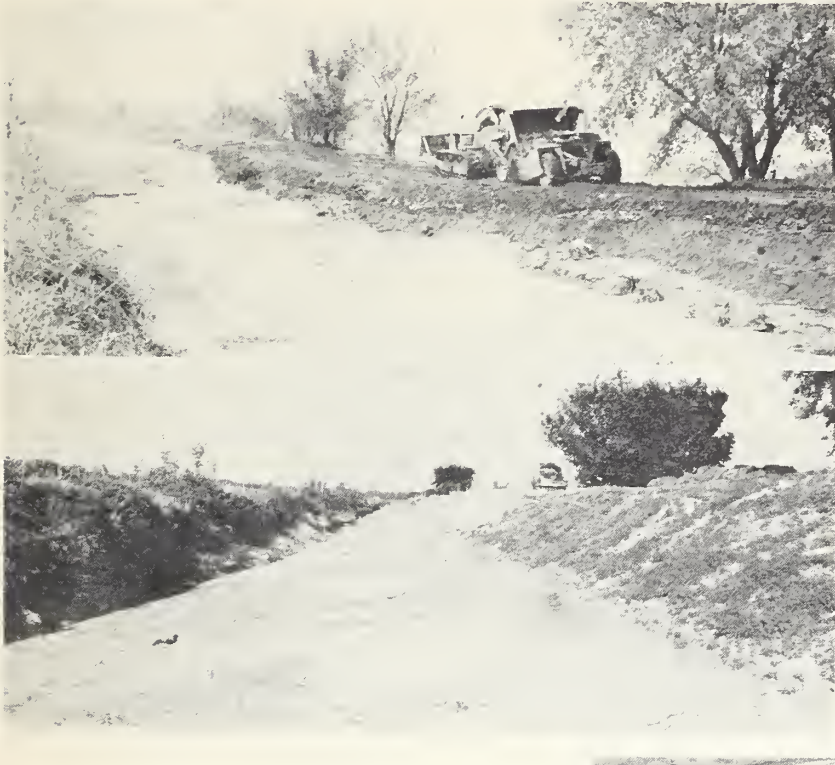
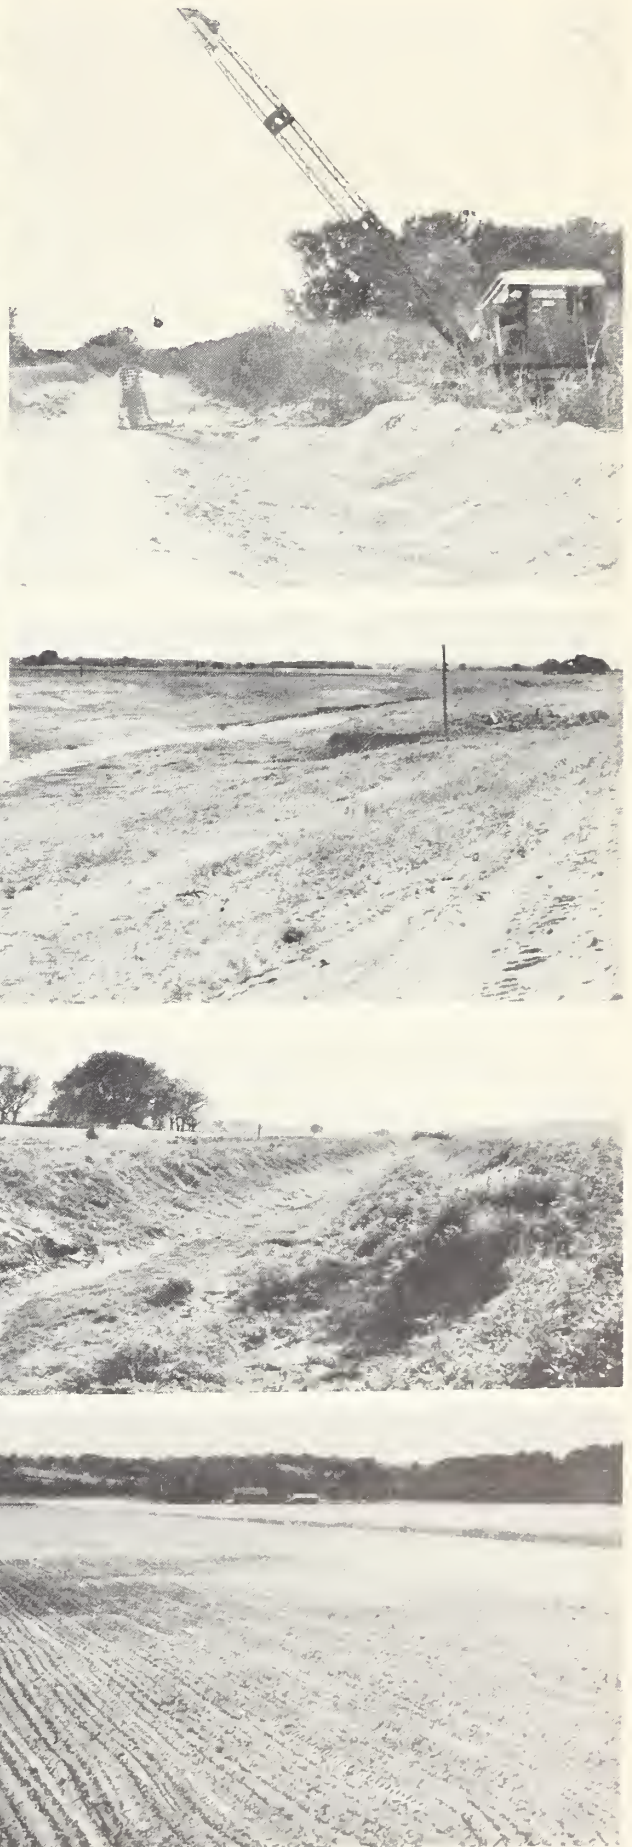
The two pictures at the upper left are repeats of the upper left view on page 14. One shows the carry-all and tractor with bulldozer blade repairing the break in the bank. Below is a view of the finished job.

Upper right is one of the draglines used in the removal of silt. Note the depth of the cut.

Second from top (right) shows the rehabilitated channel where floodwaters had destroyed the bridge.

Next to bottom (right) is a view of the place where the wall became lodged, and a general view of the restored drain.

The bottom view shows the gully, which the floodwaters started, had been eliminated.

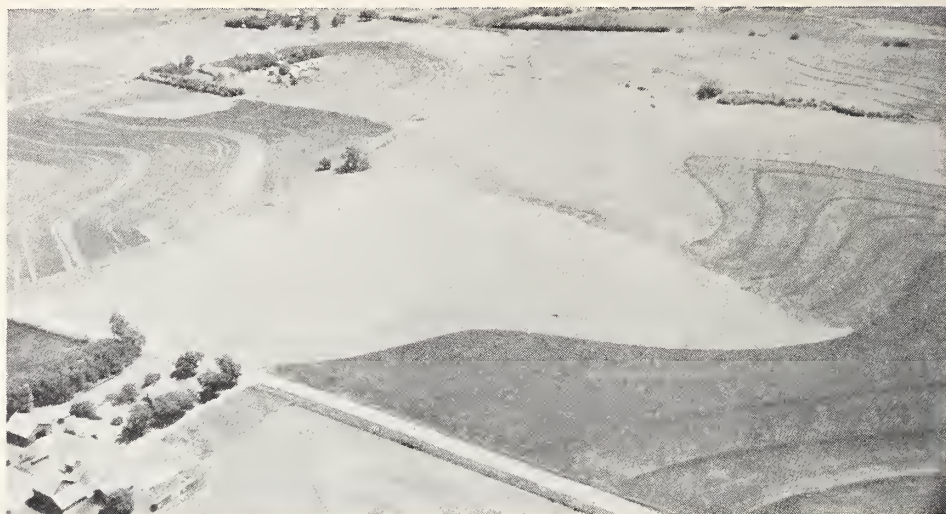
Losses on the floodplains along the tributaries

were placed at \$108,350,000. Slightly over 85 percent was damage to crops, farm buildings, fences, farm machinery and equipment, and loss of livestock. It is estimated this would have been reduced by one-third by watershed treatment. Slightly over 8 percent of the bottomland damage was to land through scour, deposition, streambank erosion and swamping, which could have been cut a third. The balance of the damage was the silting of reservoirs, and an estimate of silting that would have occurred in authorized reservoirs if they had been built. These damages could have been reduced by more than half.
